## AUSSIE SKIN 550G/560G – Repair Guidelines

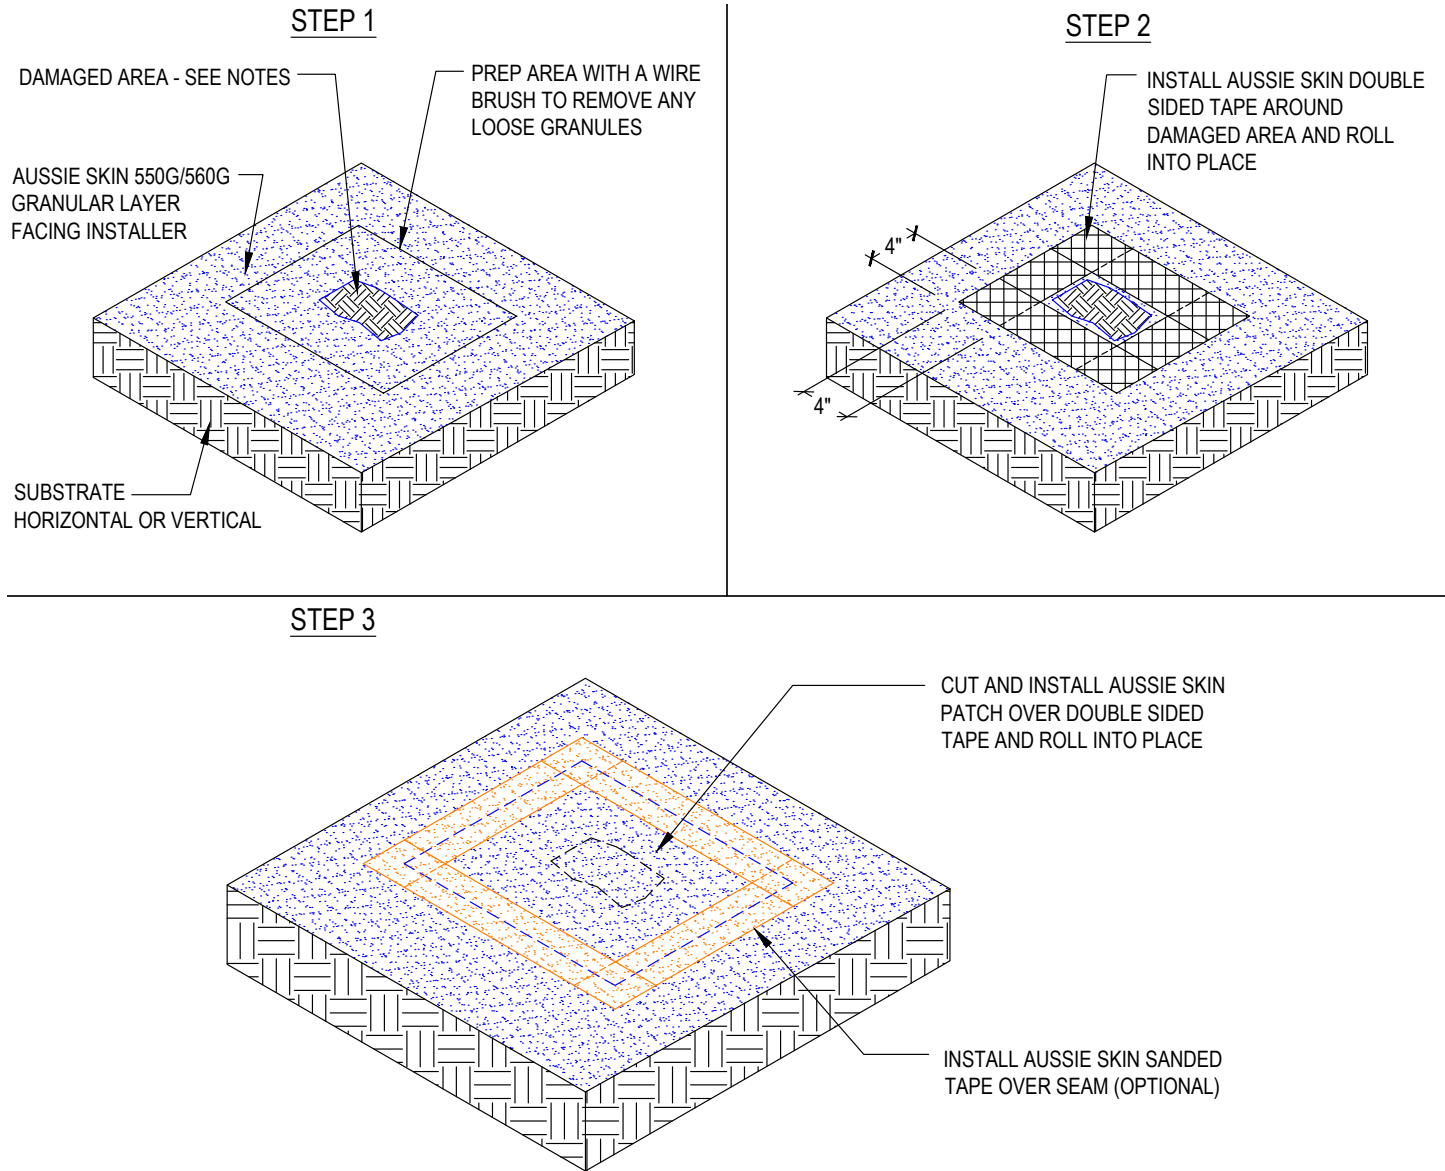
Figure 1 - Repair Procedure for Large Areas of Damage - Sande Side

- Large area of damage or a cutout area from a misplaced penetration
  - Wire brush area to remove loose granules 4" around the extent of the damage
  - Install Aussie double sided tape (4") around damaged area onto sound Aussie Skin

- Cut and install Aussie Skin patch and roll into place
- Small punctures, nail holes, etc. (non-water table)
  - Wire brush area to remove loose granules
