AUSSIE Mate 580-AL – Repair Guidelines

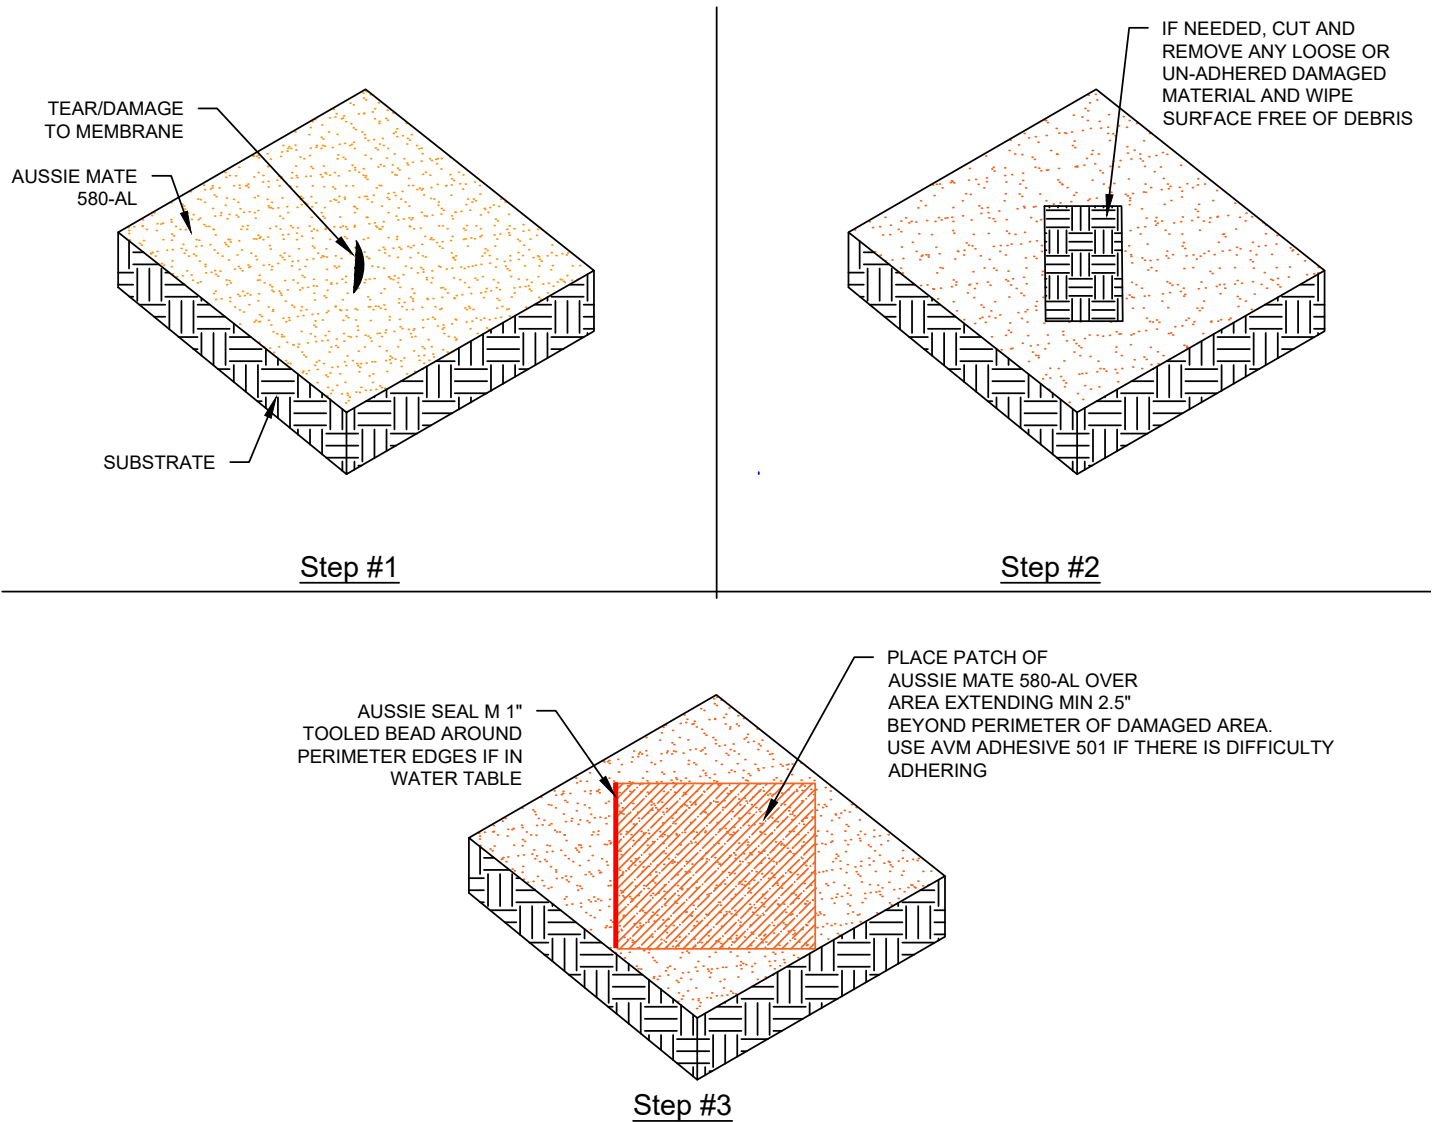
Figure 1 - Repair Procedure for Aussie Mate 580-AL

Punctures, nail holes, damage, a cutout area from a misplaced penetration, etc. (non-water table)

Punctures, nail holes, damage, a cutout area from a misplaced penetration, etc. (water table)

- Cut out and remove any loose or unadhered damaged material
- Wipe away any dirt or debris
- Install a patch of Aussie Mate 580-AL over the slice that extends a minimum of 2.5" in all directions
 - If patch above is not adhering to sliced area, AVM Adhesive 501 can be placed prior to patch

- Cut out and remove any loose or unadhered damaged material
- Wipe away any dirt or debris
- Install a patch of Aussie Mate 580-AL over the slice that extends a minimum of 2.5" in all directions
 - If patch above is not adhering to sliced area, AVM Adhesive 501 can be placed prior to patch
- Place 1" tooled bead of Aussie Seal M around the entire perimeter edge of patch
