DETAIL #:
0100-FEC-870-P-CS
AVM System 100
Forevercoat

Tooled Control Joint

AVM System 100 Forevercoat

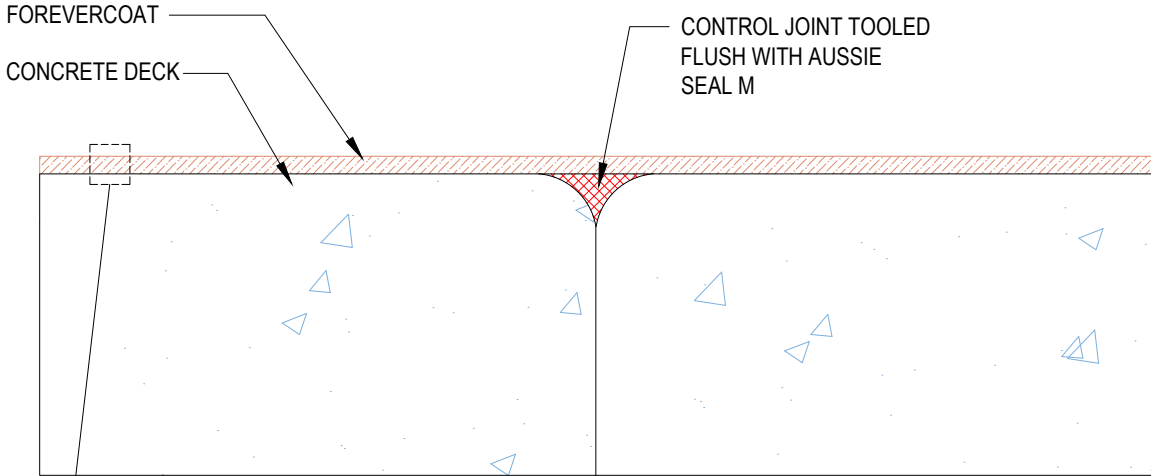
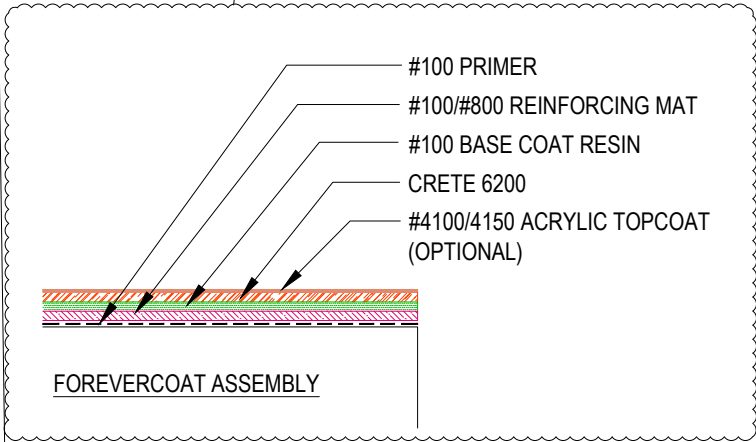
- 1. Excessive movement at the joint may cause the deck coating above the sealant to crease, deform or fail. Additional Periodic inspections and maintenance of these joints may be required.
