AUSSIE Clay 590 – Repair Guidelines

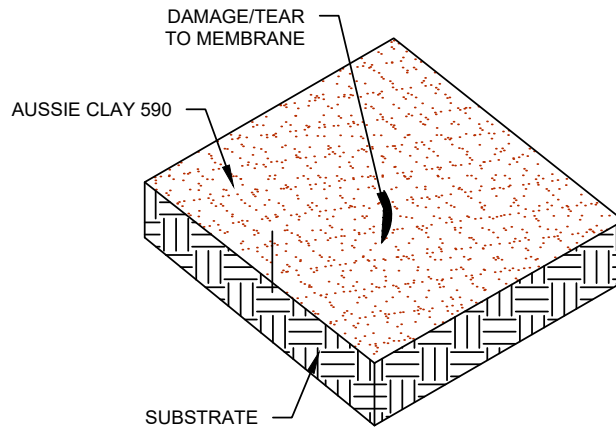
Step #1

- Slice in the membrane
 - Install Aussie Clay patch centered over the slice that extends 4" around perimeter of slice
- Large area of damage or a cutout area from a misplaced penetration
 - Install Aussie Clay patch over the damage that extends 4" around perimeter of damaged area
- Displacement of bentonite in membrane due to pre-hydration
 - Remove any standing water and allow membrane to dry
 - Install Aussie Clay patch over the damage that extends 4" around perimeter of displaced area

Figure 1 - Repair Procedure for Aussie Clay 590
